Central Square : Hampstead Garden Suburb NW11

2. Site History:

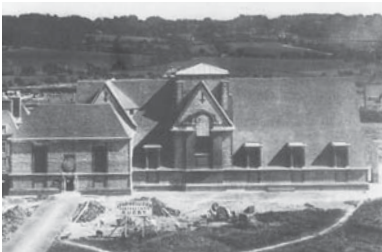
<p>c. 1906-7: Edwin Lutyens early formal interpretation of Unwin's plans for Central Square.</p>

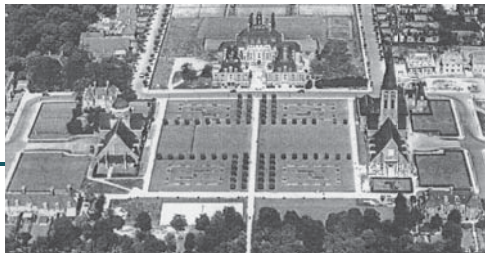
<p>1930: Aerial photo showing the Square becoming more formal and now with only a single row of trees running North to South.</p>

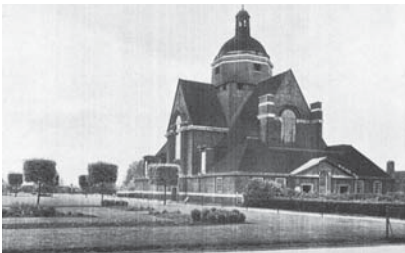
<p>1930: Lime trees now formally managed with box-head form. Adjacent hedging is kept at a low height next to the Free Church.</p>

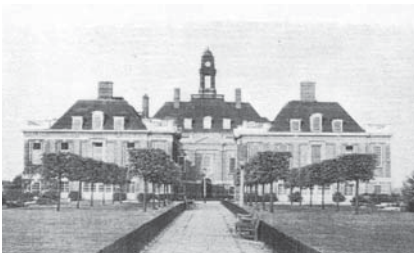
<p>1930: Box-headed Lime trees frame the Hampstead Garden Suburb Institute building with low hoop-top fencing enclosing the grass.</p>

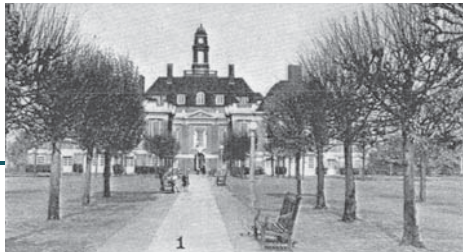
<p>1950: Lime trees beginning to lose their box-headed form as they grow in size, and the central axis path has a reduced width.</p>

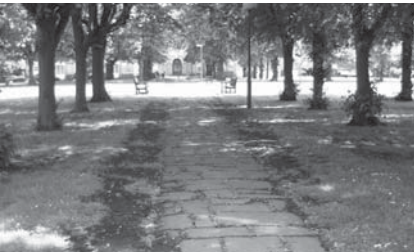
<p>2008: Present day decline shows the main pathway surface in disrepair, and views down the central axis lost.</p>

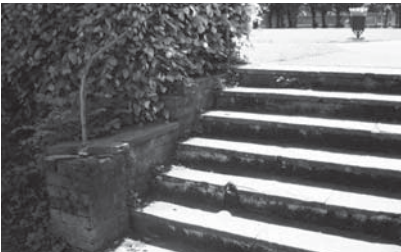
<p>2008: General features and stonework in decline, coupled with encroaching vegetation which has become overgrown.</p>
